# Damage Detection and Performance Evaluation of Photovoltaic Panels Used in Rural Area through Thermography Analysis

Sedigheh Sorkhani, Masoud Iranmanesh\*, Naimeh Gholamrezaei

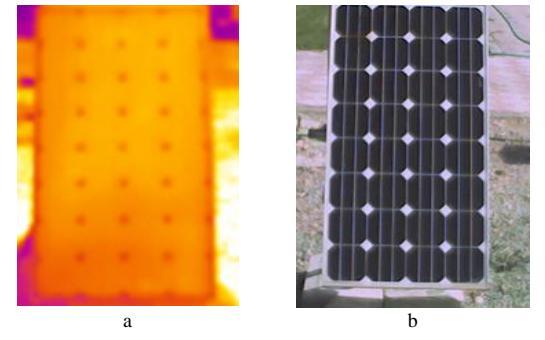
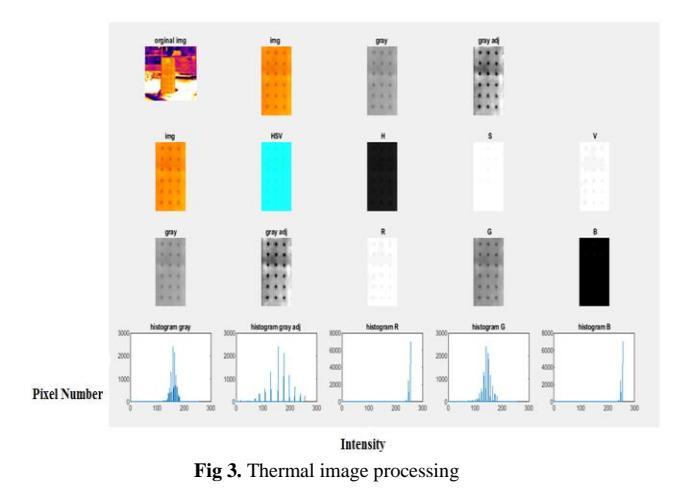
Fig. 2 shows the thermal and digital images of the healthy panel.

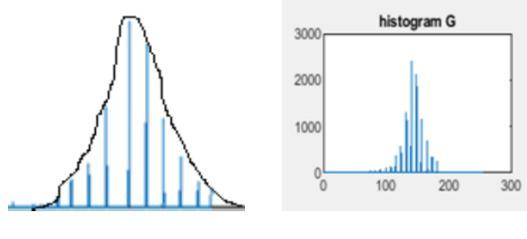
Fig 4. Thermal image histogram

According to the investigations, the HSV color space and the G channel show the panel defects better, and the histogram of the G channel and the GRAY image correspond to the normal distribution diagram (Fig. 4).

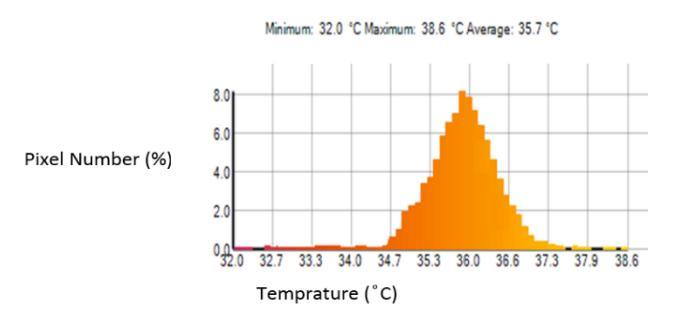
Fig 5. Histogram related to the camera software

In the histogram of the thermal image obtained by the camera software according to the temperature of the panel points, the horizontal axis of the temperature graph and the vertical axis show the percentage of the number of points that have a certain temperature (Fig. 5). According to the graph, the lowest temperature is 32 °C, the highest temperature is 38.6 °C and the average temperature in most places is 35.7 °C. The histogram of Fig. 5 and the histogram of Fig. 4 both correspond to the normal distribution diagram.

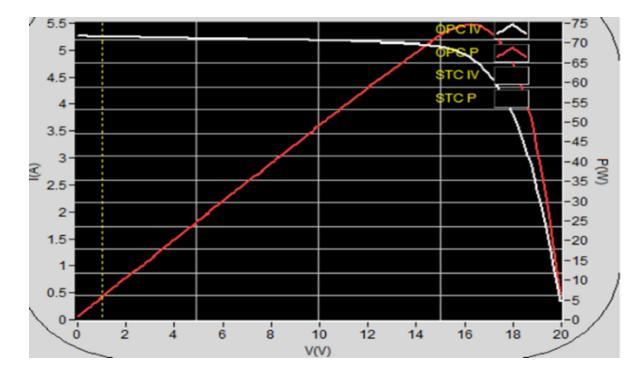
Fig 6. Voltage, current, and power diagram of a healthy panel

In general, in Fig. 6, the voltage and power of the panel do not show a significant drop.

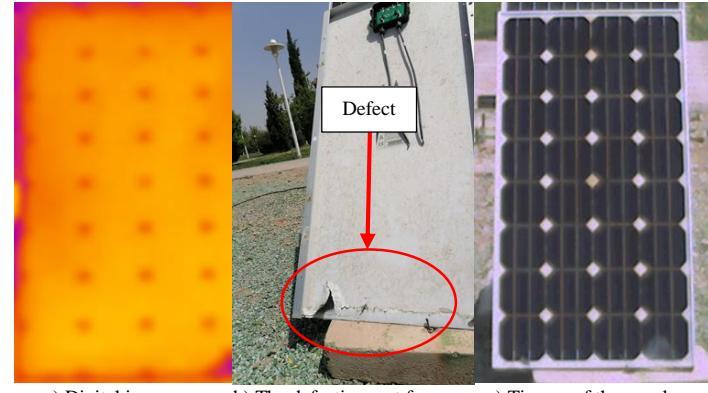
Fig 7. Thermal and digital image of the defective panel

Fig. 7 shows the thermal and digital image of a healthy panel that is artificially damaged. Fig. 8 shows the image processing of the defective panel. The HSV color space and the H channel of the defective cell are shown in white and the rest of the channels are shown in a darker color. Fig. 9 shows the faulty cell in the camera software as the coldest point.

a) Digital image b) The defective part from c) Timage of the panel the back of the panel

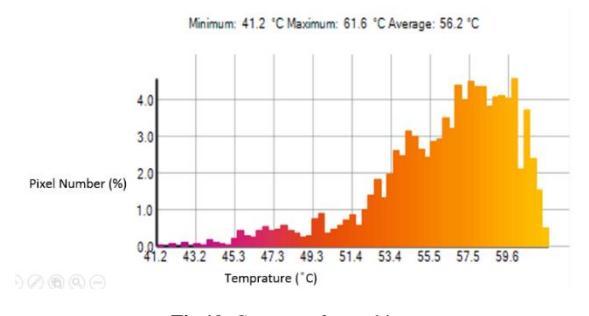
Fig 10. Camera software histogram

Fig. 10 shows the histogram of the thermal image obtained by the camera software according to the temperature of the panel points. The horizontal axis shows the temperature and the vertical axis shows the percentage of points that have a certain temperature. According to the graph, the lowest temperature is 32.6 °C, the highest temperature is 48.2 °C, and the average temperature in most places is 39 °C. In the histogram of Fig. 8 and Fig. 10, both graphs stretch to the left, which does not correspond to the normal distribution graph.

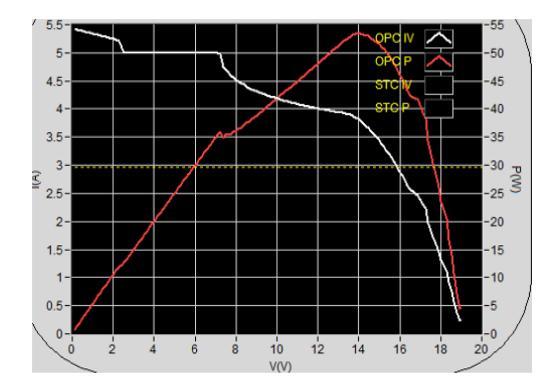
Fig 11. Voltage, current, and power diagram of a defective panel

Fig. 11 shows the current and voltage curve (white color) and the power and voltage curve (red color). The reading from this figure are shown in Table 6. The FF has decreased significantly from 0.7 to 0.5, and other parameters, including the short circuit current, have increased slightly from 5.3 to 5.4A. The open circuit voltage has decreased from 20.2V to 19.04V and the panel power has decreased significantly. As it is clear from Fig. 11, when the panel is healthy, it can produce nearly 80 W of power, and when the panel is defective, the power is reduced to 53.3 W. In general, Fig. 11 shows a significant drop in panel power.
